Manhole Inspection Summary

Manhole # S15QQ1002MH

Location Address: **4891 YELLOWWOOD AVE**

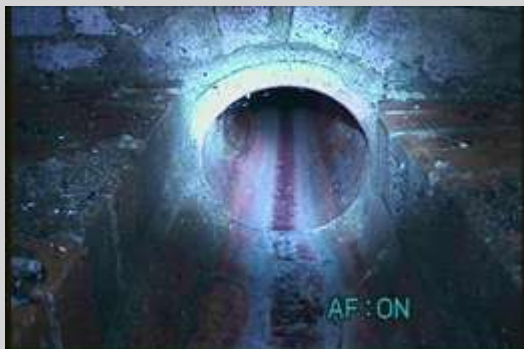
8 in. Circular Gravity Sewer Pipe In @ 6 O'Clock

Deposits: ☒ None ☐ Mud ☐ Sludge ☐ Debris ☐ Grease

Infiltration: **None** Pipe Seal Cond: **Unknown**

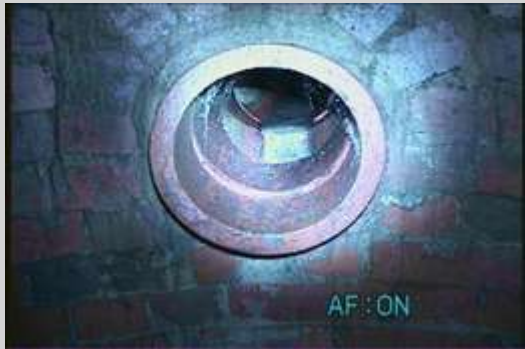
8 in. Circular Gravity Sewer

Infiltration: **None**

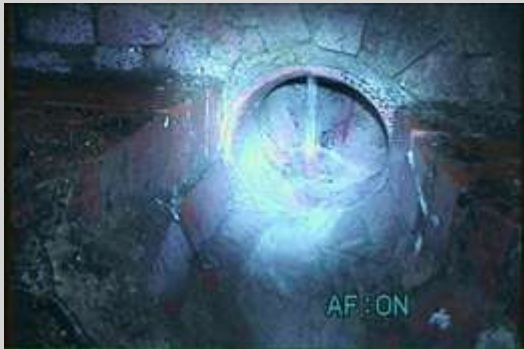
Drop In @ 9 O'Clock

Drop: Outside	Rod and Bar
Angled: Yes	Reading: 10.58 (ft.)
	Inv Depth: 11.58 (ft.)
Drop Condition: Open
